Manhole Inspection Summary

Manhole # S45UU_024MH

Insp Date: **2/6/07 11:40 AM**

Location Address: **1828 28TH AVE**

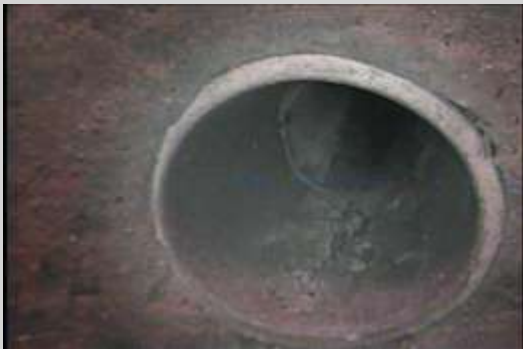
8 in. Circular Gravity Sewer Pipe In @ 3 O'Clock

Deposits: ☒ **None** ☐ Mud ☐ Sludge ☐ Debris ☐ Grease

Infiltration: **None** Pipe Seal Cond: **Unknown**

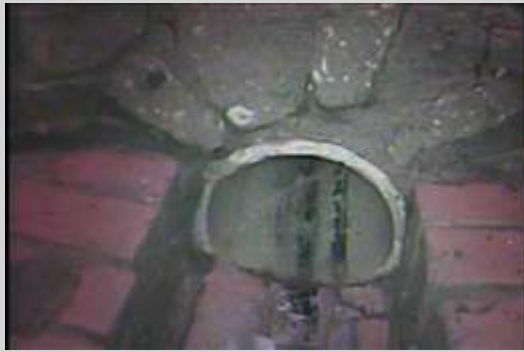
8 in. Circular Gravity Sewer

Infiltration: **None**
